Gland Bush Replacement (TB2 - TB10 models)

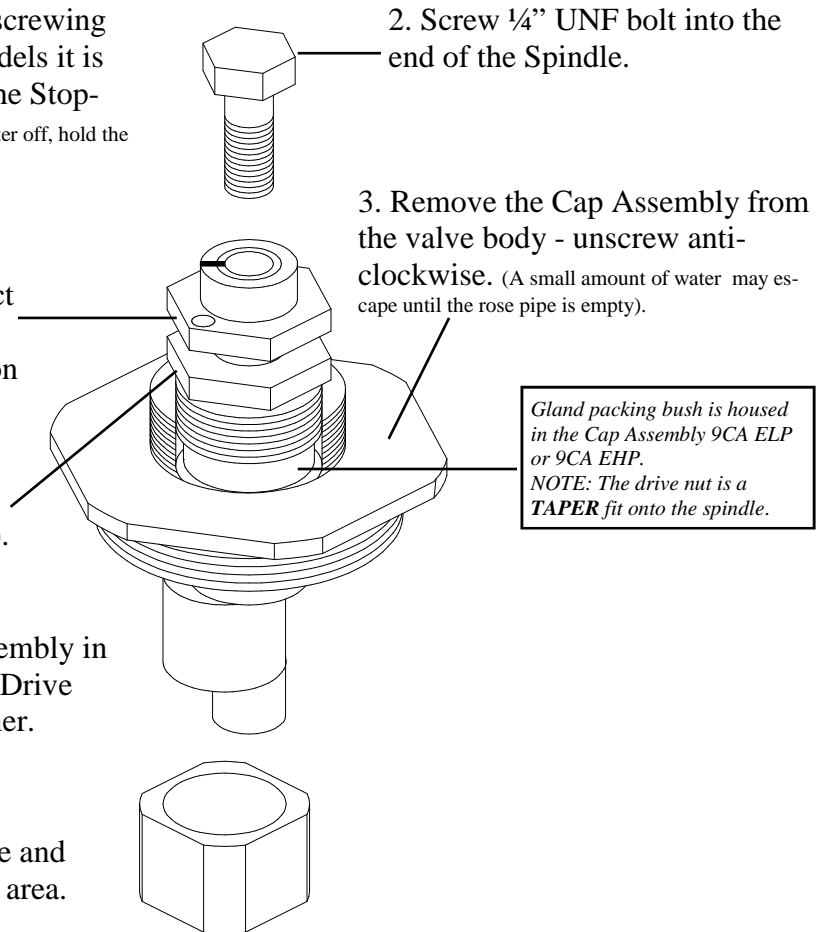
4. Mark the relative position of Spindle and Drive Nut with a felt pen to ensure the correct replacement position of the Drive Nut. (The 'Off' position is indicated by a punch mark on the Drive Nut which faces towards the outlet to the rose).

6. Drive Nut Removal - support the Cap Assembly in a vice, drive the tapered Spindle through the Drive Nut by hitting the ¼" UNF bolt with a hammer.

9. Press the Drive Nut back onto the tapered Spindle by pressing in a vice or insert the ¼" UNF bolt, a nut and washer and screw the nut down. (The 'Off' position is mid-way in the free-play before either valve opens).

10. Fit the Cap Assembly back into the valve (no need to overtighten) and seat the Gland by tightening the Gland Nut firmly (approx 33Nm or 25lb-ft), then adjust back until firm enough to prevent the valve springs allowing the control to creep closed and no leaks appear when in operation.
